# HOWARD COUNTY HISTORIC PRESERVATION COMMISSION

## April Agenda

Thursday, April 4, 2019; 7:00 p.m.

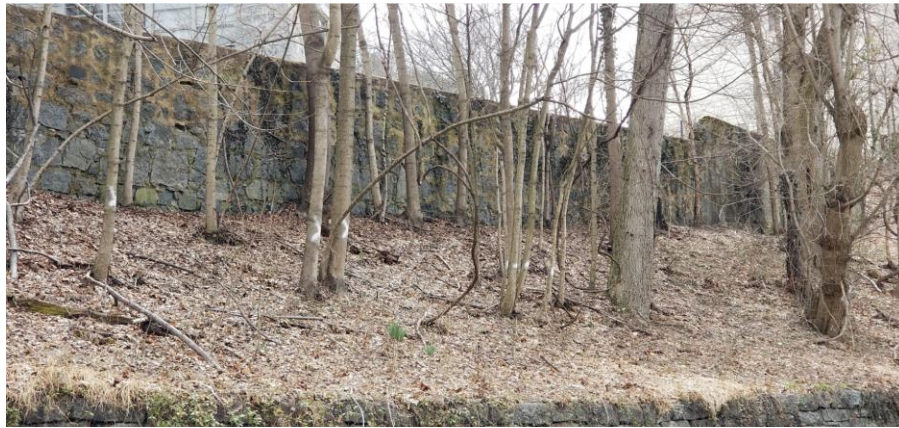
Figure 1 - View of several of the trees to be removed.

**Staff Comments:** The removal of trees is proposed so that the BGE poles can be relocated to the other side of the street, to repair the roadway damage that occurred as a result of the May 2018 flood. The Guidelines do not currently address situations such as these. Chapter 9.B recommends against the “removal of live mature trees, unless it is necessary due to disease or to prevent damage to historic structures.” In this instance, the removal of the live mature trees is needed to repair flood damage that resulted in the collapse of major portions of the roadway.

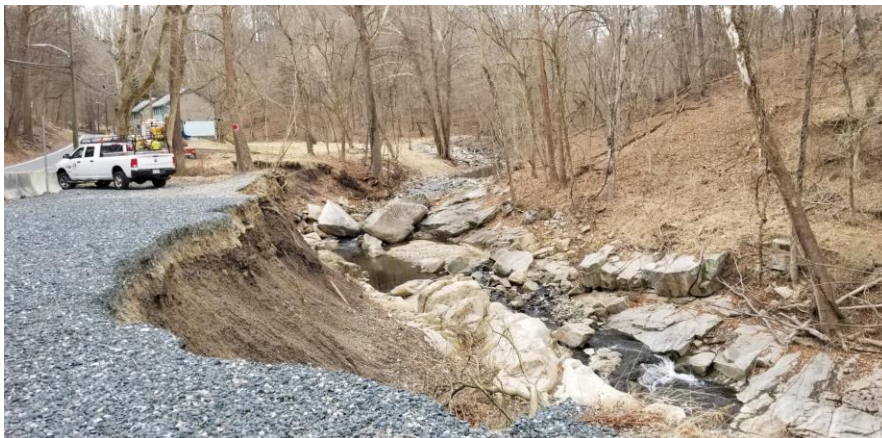
Figure 2 - Damage from May 2018 flood

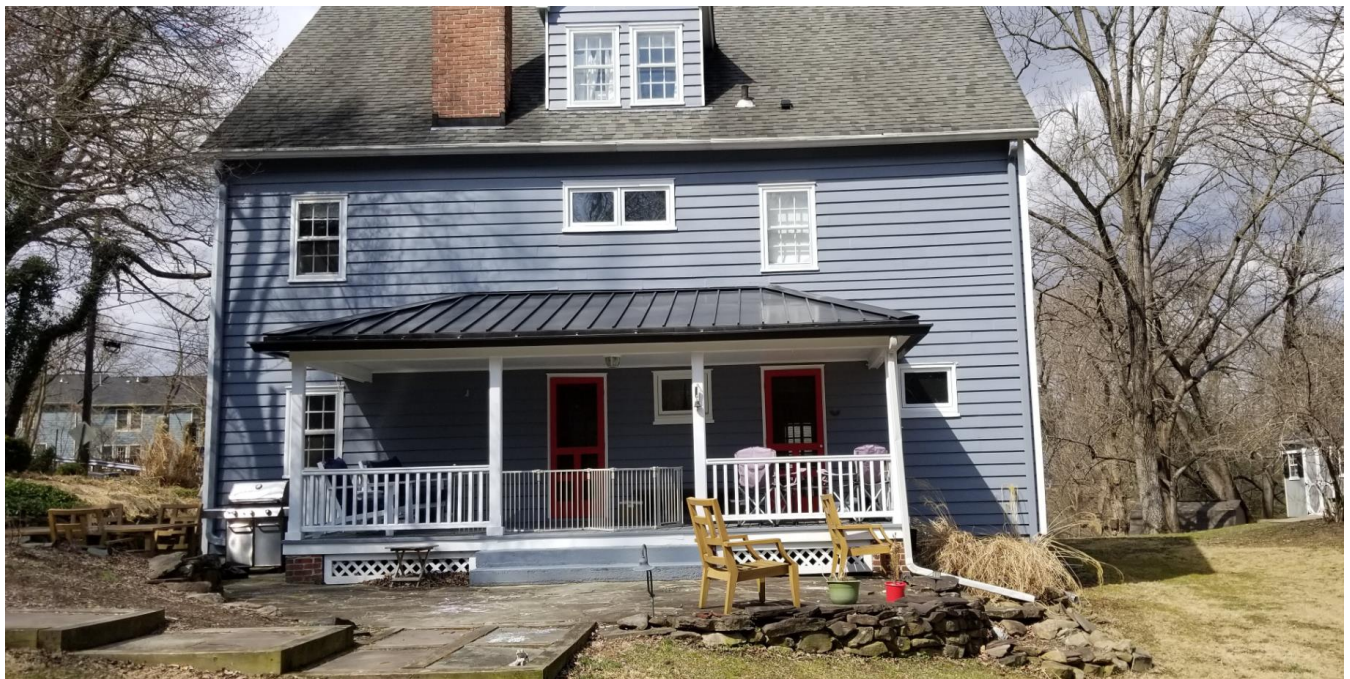
Figure 3 - Side view of house

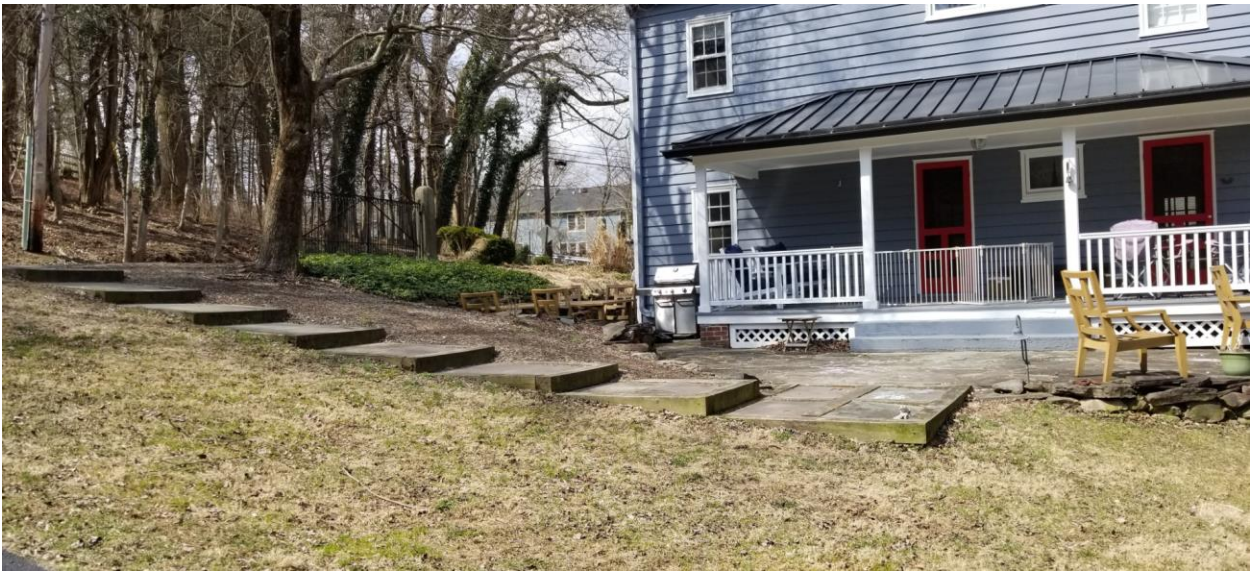
Figure 4 - Steps and patio/terrace to be removed and replaced

The use of gravel walkways, the stone patio/terrace and the bluestone porch tread complies with Chapter 9.B recommendations, “construct new terraces or patios visible from a public way from brick, stone or concrete pavers designed to look like indigenous stone” and “construct new site features using

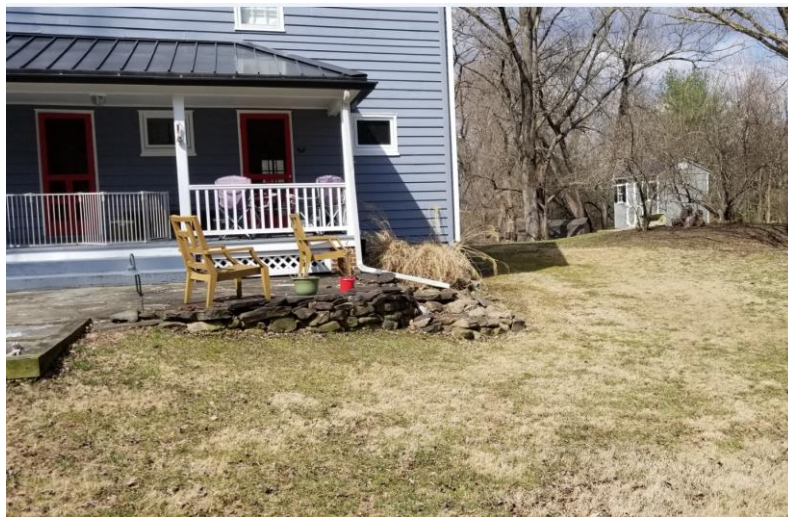
Figure 5 - Location of refuse walkway and parking pad

The location and construction of the parking pad off the common driveway complies with Chapter 9.B, which recommends, “where needed, install new residential driveways that are narrow (one lane) and follow the contours of the site to minimize the need for clearing and grading. If possible, locate off-street parking spaces in side or rear yards.”

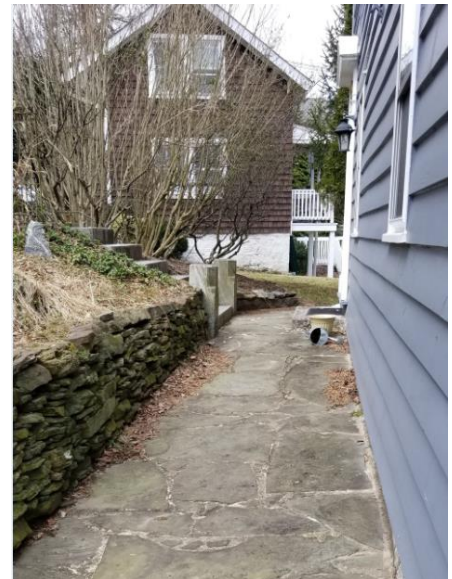
Figure 6 - Stone walkway to be replaced with gravel front Ross Road

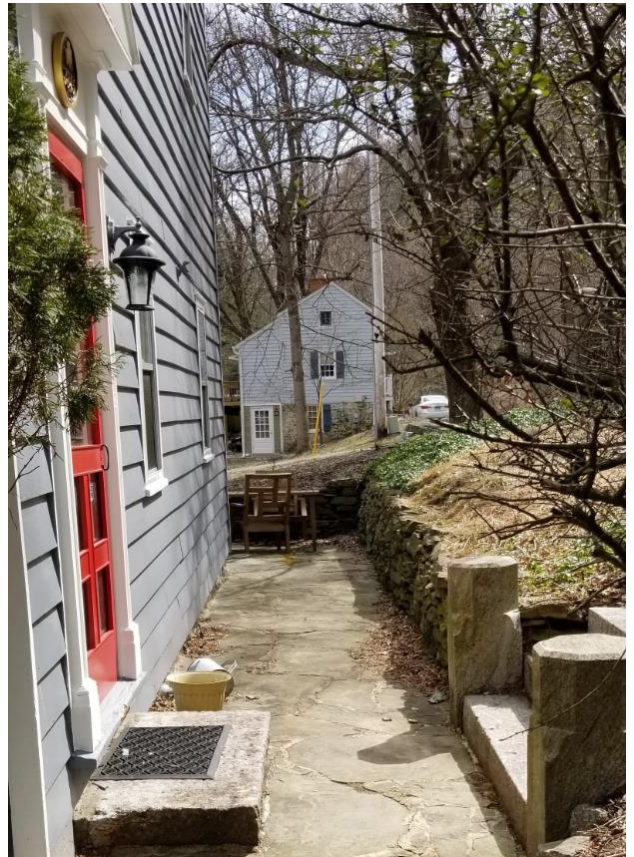
**Figure 7 - Portion of retaining wall to be removed for gravel walkway and patio. Boulders to retain the hillside on the right.**

materials compatible with the setting and with nearby historic structures, particularly for features visible from a public way.” The repair of the existing retaining wall complies with Chapter 9.B, which recommends, “preserve historic features, such as retaining walls, freestanding walls...When possible, reuse the historic building materials to repair or restore these structures.” A portion of the retaining wall will be removed to expand the patio area, as shown on the site plan, and large Pennsylvania boulders will be installed to retain the hillside. Landscape beds will be installed on either side of the porch.

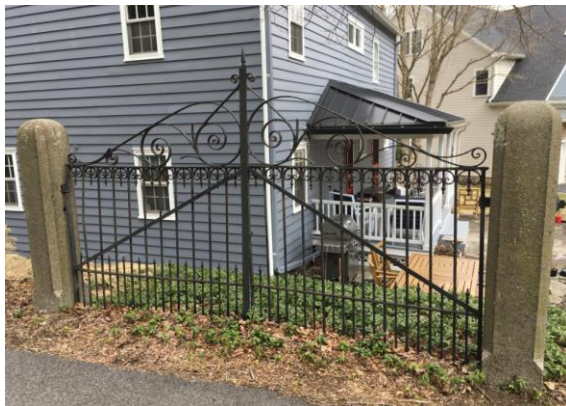
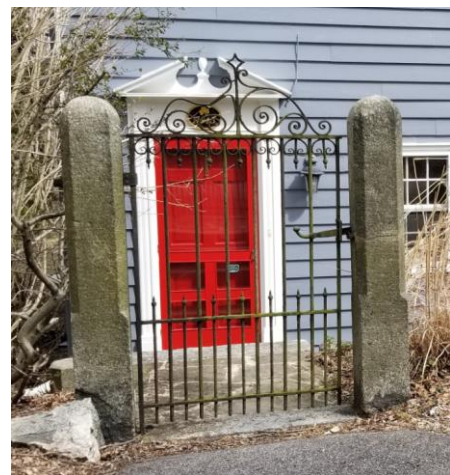
**Figure 8 - Existing historic wrought iron gate**

**Figure 9 - Existing historic wrought iron gate**

The proposed wrought iron hand railings to flank the porch steps will be designed to match the existing historic iron gates on the property, shown below in Figures 8 and 9. The continued use of this design complies with Chapter 9.B, which recommends “construct new site features using materials compatible with the setting and with nearby historic structures, particularly for features visible from a public way.” It would also be typical to see a handrailing along the steps in the same design as the wood porch railings as well.

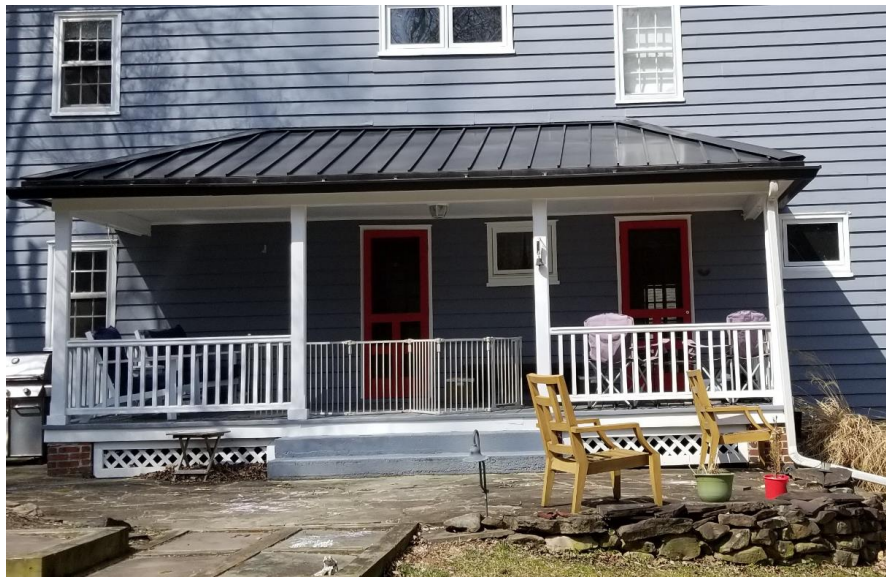
**Figure 10 - Porch**

- 5) **Trees** - Remove one diseased tree and replace the tree with two ginkgo trees.
- 6) **Porch** – Install blue stone treads on existing concrete steps and paint the concrete risers white. Install a custom iron handrail along stairs. New handrail to match the historic wrought iron gate on the property.

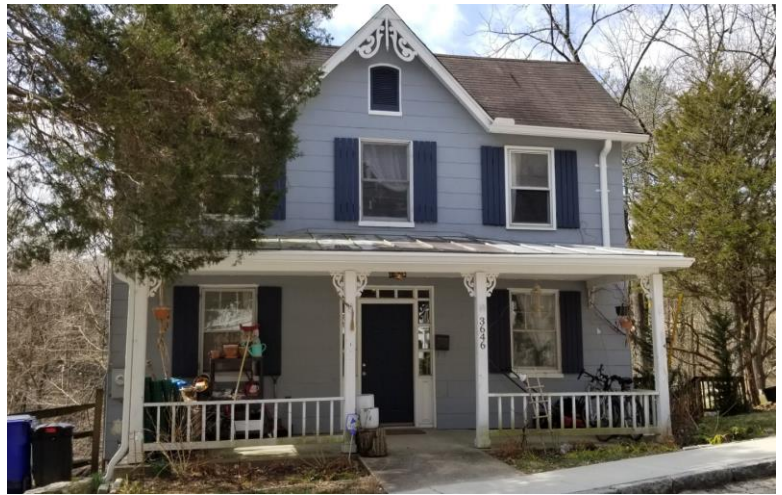
Figure 11 - Existing colors on house

Chapter 6.N recommends, "use colors that were historically used on the building" and "use colors appropriate to the period and style of the building." The light pink color would not have been used historically on this building although the dark green door and black shutters are historically appropriate for the period and style.

1. Approval of painting the siding in a true white, off-white or gray, such as Behr Angel Feather or Silent White.
2. Approval of painting the door in Behr Perennial Green, a light forest green.
3. Approval of painting the shutters in Behr Totally Black.
4. Approval of replacing damage wood trim with new wood trim. Staff recommends tax credit pre-approval.
5. The Commission determine the necessity of removing the two 6:6 wood windows on the first floor and otherwise recommends tax credit pre-approval if repaired.
6. Staff recommends denial of adding new vinyl louvered shutters on the side windows.

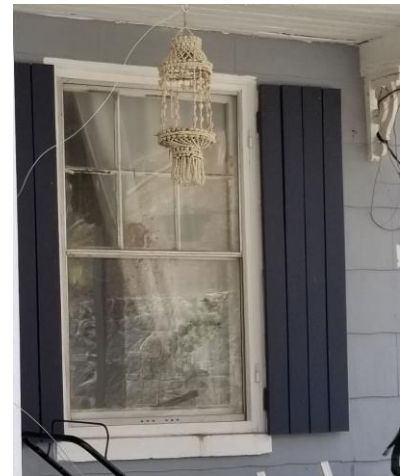
Figure 12 - Existing 4 board wide board and batten shutters

The Applicant proposes to add black, vinyl louvered shutters to the first-floor windows located on the west side of the house. The other shutters on the house are wood board and batten shutters that are 4 boards wide with the batten on the backside. The black color complies with the Guidelines but the material and style of the proposed vinyl, louvered shutters do not comply with Chapter 6.I recommendations, "for replacements, install shutters or blinds that maintain the size, style and placement of the original." Chapter 6.I also recommends against using "aluminum or vinyl shutters or blinds."

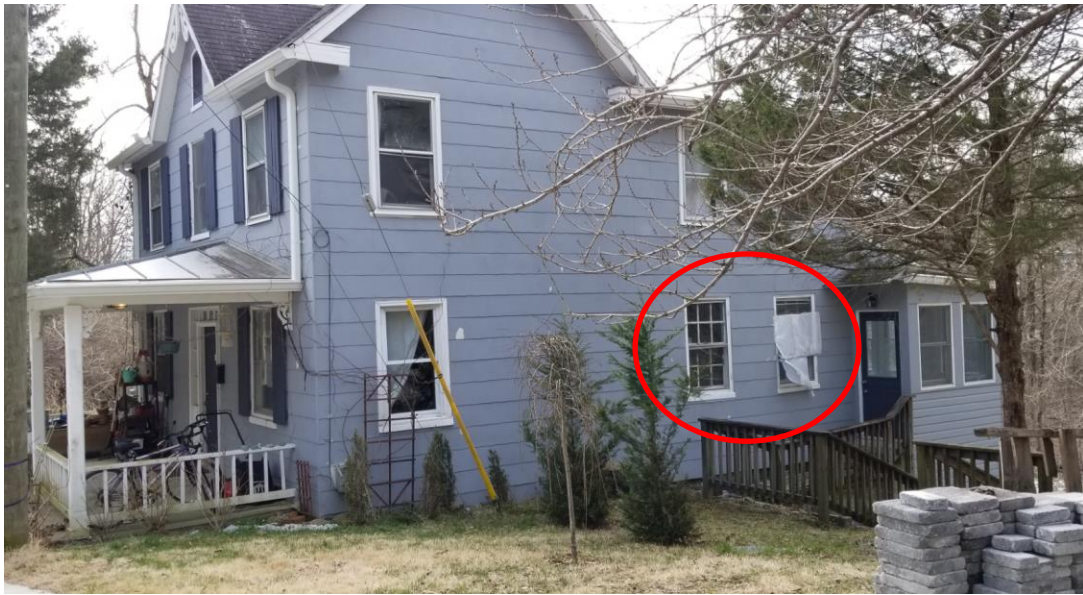
**Figure 13 - Two 6:6 windows to be replaced**

The majority of the existing windows on the house are not original and are a mix of 1:1 wood and vinyl windows. The windows under the front porch are 6:1 wood windows and appear to be original. The proposed 6:6 wood windows to be removed appear to be original, but the other windows on this side of the house are all 1:1 and have already been replaced with vinyl. The application did not document damage to the windows, necessitating removal and replacement, versus repair. Chapter 6.H, states, "vinyl or metal replacement windows do not have the same profile and detailing as wood windows and should be avoided on historic buildings." Chapter 6.H recommends "when repair is not possible, replace original windows, frames and related details with features that fit the original openings and are of the same style, material, finish and window pane configuration. If possible, reproduce frame size and profile and muntin detailing." While the replacement with a 1:1 window would result in the loss of original 6:6 windows, it would also result in a more cohesive window pattern on the west side of the house. The Guidelines do not support the use of vinyl windows. The use of replacement wood windows would qualify for tax credits.

If the Commission approves the removal of the 6:6 side windows, the 6:1 windows on the porch will be the only remaining clue that different windows once existed on this structure.

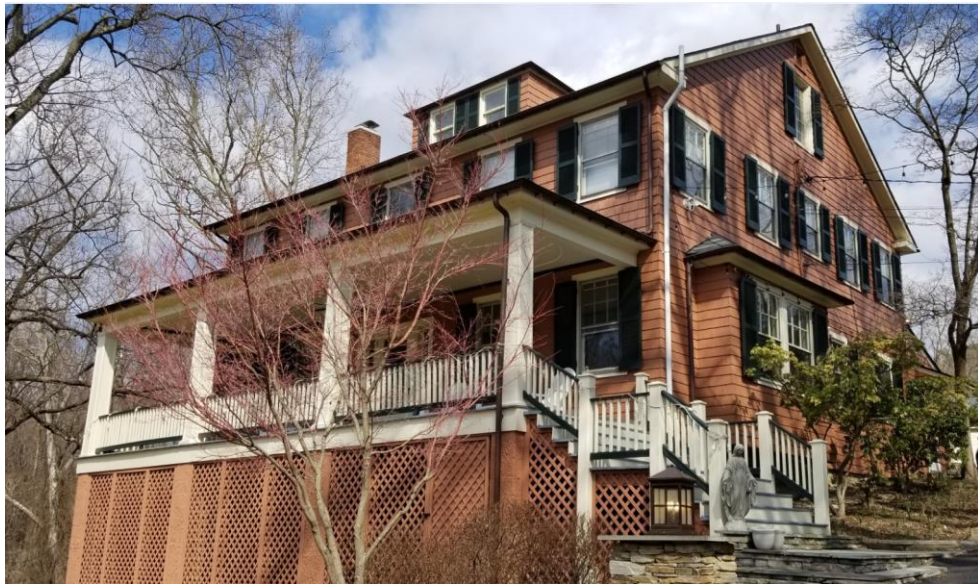
Figure 14 - Existing color scheme on house

**Staff Comments:** The application complies with Chapter 6.N recommendations for painting. The proposed colors comply with Chapter 6.N recommendations, “use colors that were historically used on the building” and “use colors appropriate to the period and style of the building.” The use of the paint scheme on the garage and outbuilding behind the garage also comply with the Guideline recommendations, “on attached buildings, use the same colors or a coordinated color scheme whenever possible.”

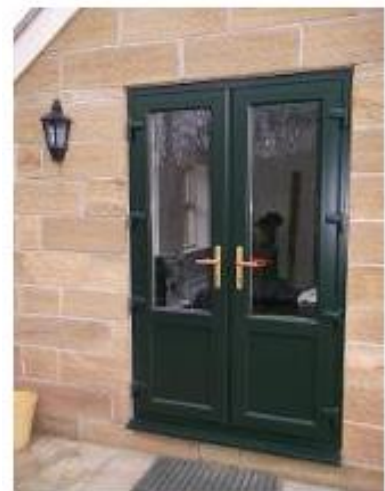
Figure 18 - Stormmeister flood door

**Staff Recommendation:** Staff recommends Approval of the Stormmeister flood doors, in a historically appropriate design as determined by the Commission and tax credit pre-approval (20.112 and 20.113) for the work.

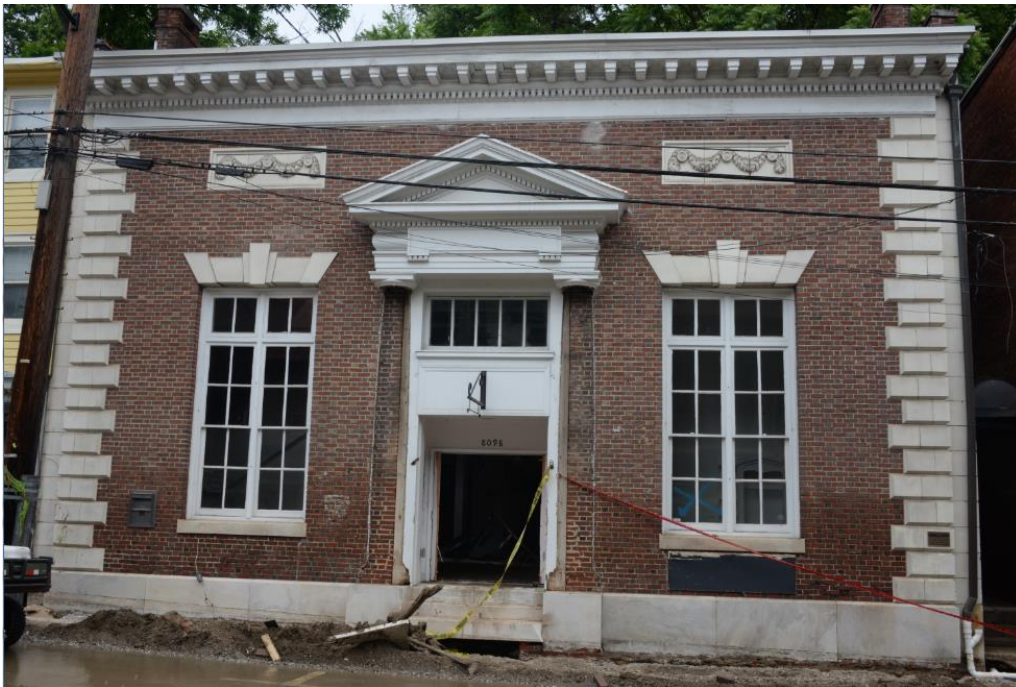
**Figure 19 - Damage from 2018 flood. Photo from May 30, 2018**

The French doors approved after the 2016 flood, were again lost in 2018. This resulted in the second set of French doors destroyed by flooding. The Applicant now proposes to install a flood door, which if installed correctly, should have a better chance of remaining on the building and lasting many years. Therefore, a historically appropriate style should be used.

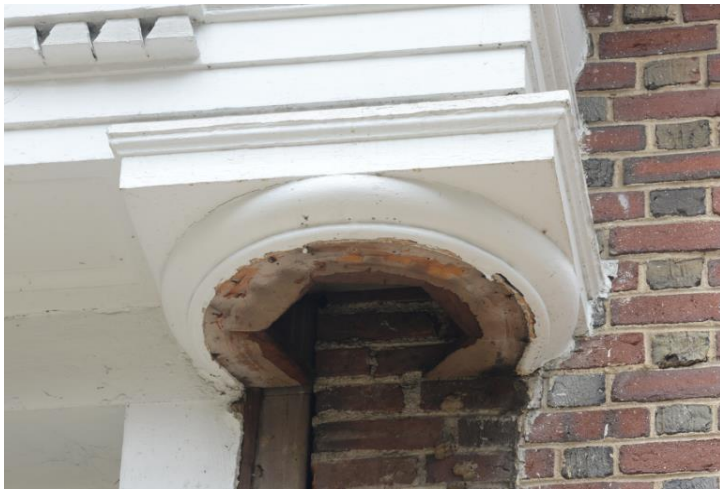
Figure 20 - Remaining capitol

The Applicant is working on obtaining additional information regarding the exterior items, as requested by Staff. Staff requested specification sheets for the capitals and bases on the column to ensure they were being replaced in-kind. The original base appeared to be Roman Doric base, which is the style that should be used for replacement.

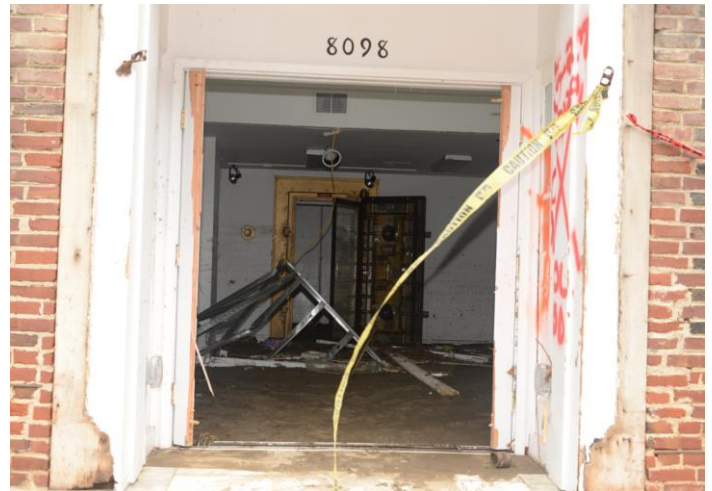
Figure 21 - View inside building

Staff recommends 20.113 tax credit pre-approval for Interior Items 6-13.
